The Information of Ping Ding Station

The disaster report

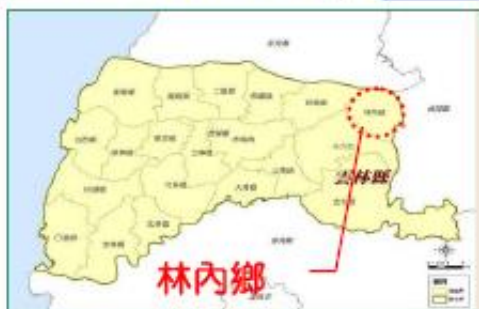
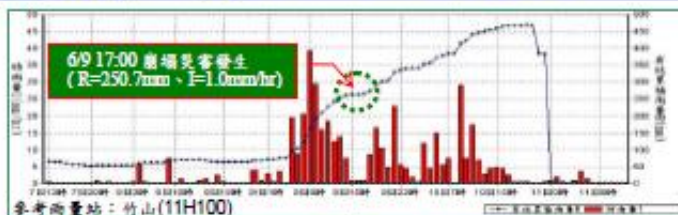
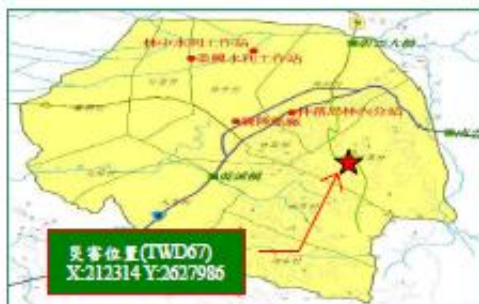
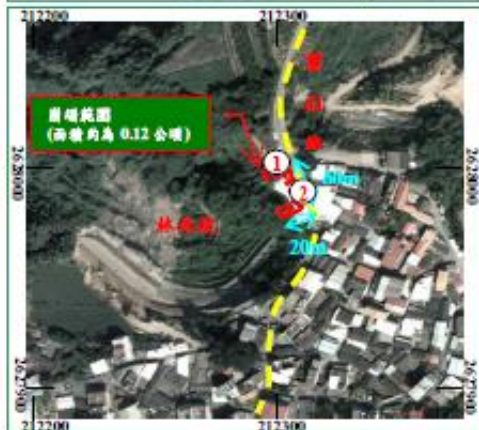
950609 豪雨-雲林林內-001

- 災害位置：林內鄉坪頂村(林北坑)
- 災害發生時間：6月9日17時
- 災害類型：崩塌災害(山崩)
- 有效累積雨量：250.7mm

- 雲61線公路之坪頂村入口路段
基邊坡土石崩塌約20公尺。
- 人命損失：0人
- 倉庫受損：2棟

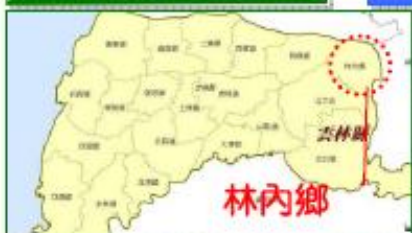
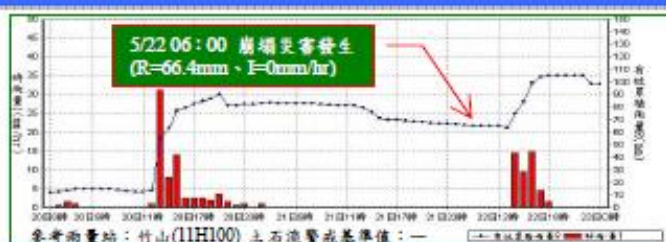
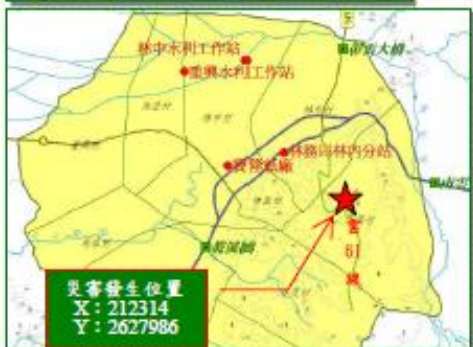
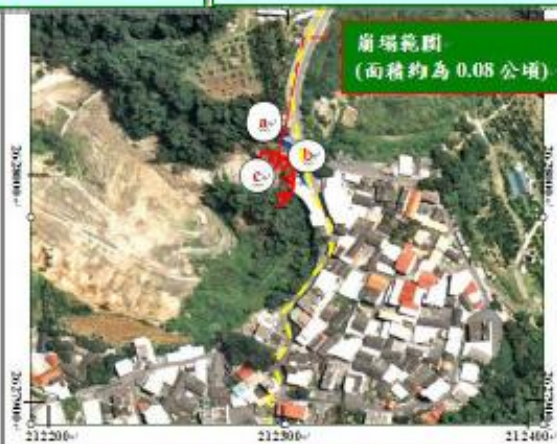
- ◆災害位置：雲林縣林內鄉坪頂村
- ◆災害發生時間：5月22日6時
- ◆災害類型：崩塌災害
- ◆有效累積雨量：66.4mm
- ◆災情描述與統計：
 - ✓ 貫 81 線公路之坪頂村入口段路基邊坡土石崩塌，路基流失約 40 公尺。
