The Information of Huashan Station

Debris flow disaster report

98年莫拉克颱風重大土石災例最速報

雲林縣—古坑鄉華山村

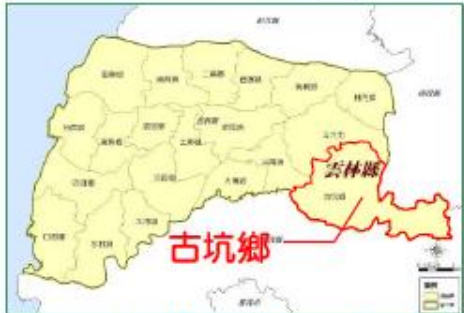
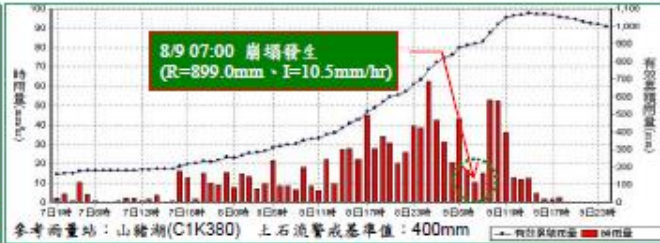
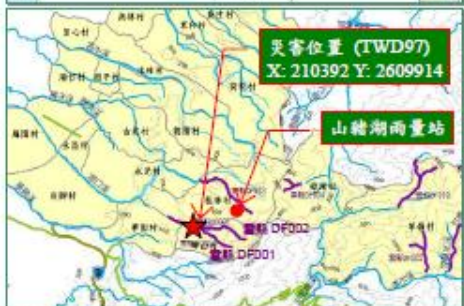
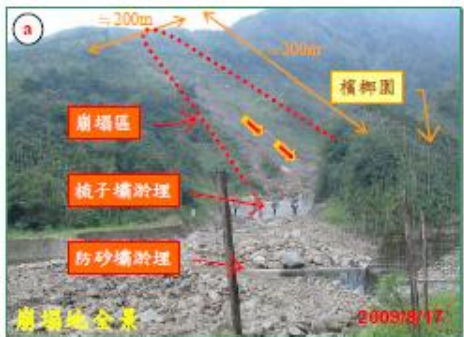
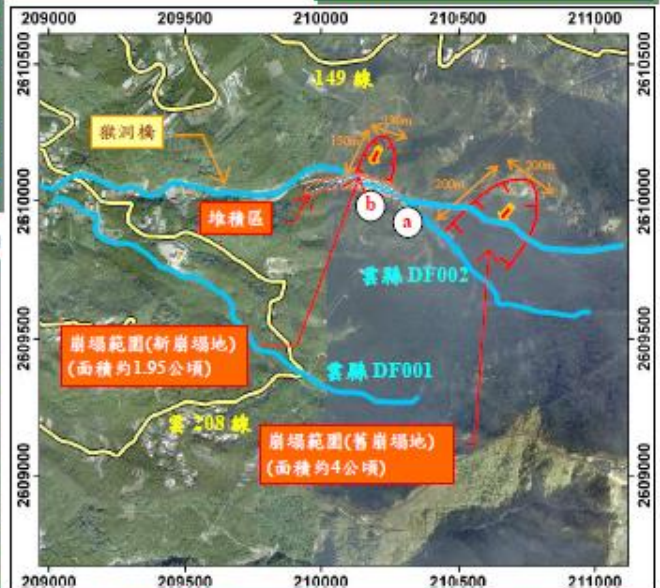
- 98年莫拉克颱風-雲林古坑-001
- 災區位置：古坑鄉華山村 (華山溪上游距發源橋約820公尺)
 - 災害發生時間：8月9日7時
 - 災害類型：崩塌
 - 有效累積雨量：899.0mm
- 災情描述與統計：
- 本次颱風豪雨造成華山溪上游既有崩塌地擴大及一處新增崩塌地，初估造成約12萬方土石堆積於主河道上，而部分土石掩沒發源橋上方施工便道，目前已清理完畢。
 - 施工便道遭土石淤埋約820公尺。
