## The Information of Daniao Station

**Daniao**  
Debris Flow Monitoring Station

## Debris flow disaster report

**98年莫拉克颱風-台東大武-002**

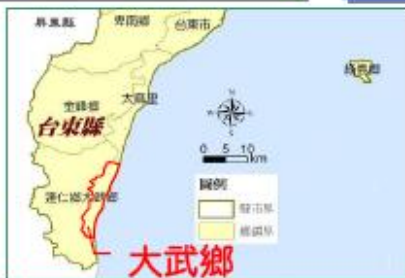
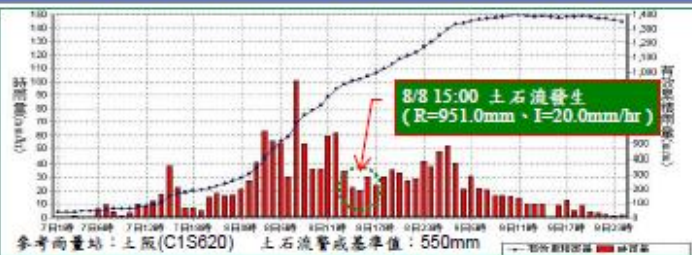
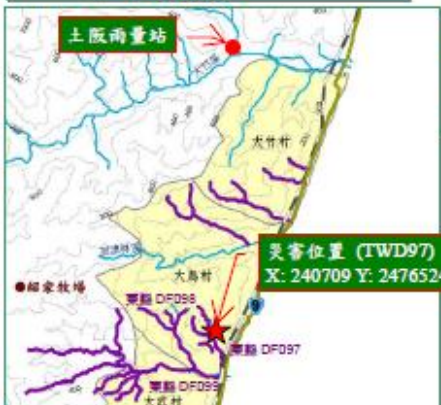
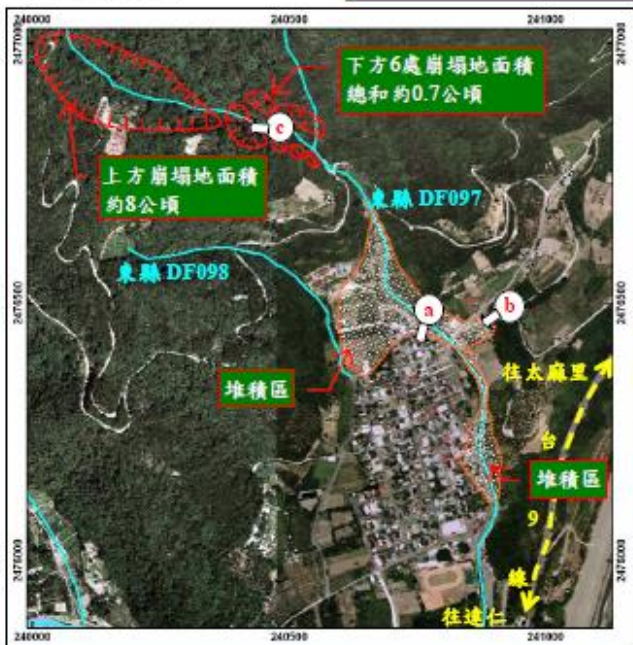
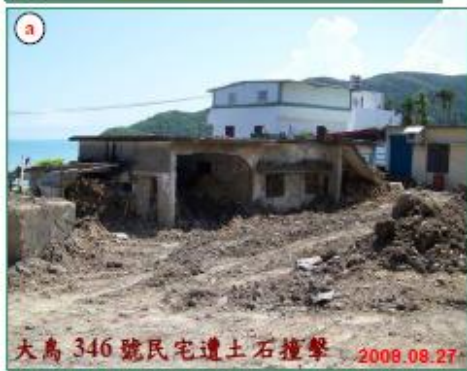
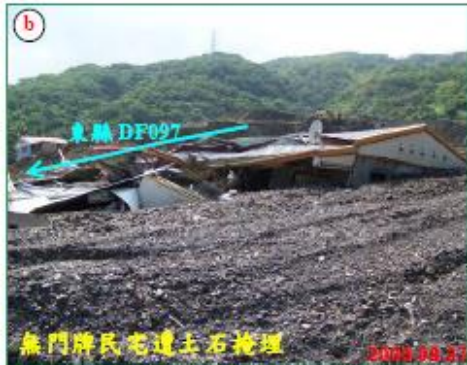
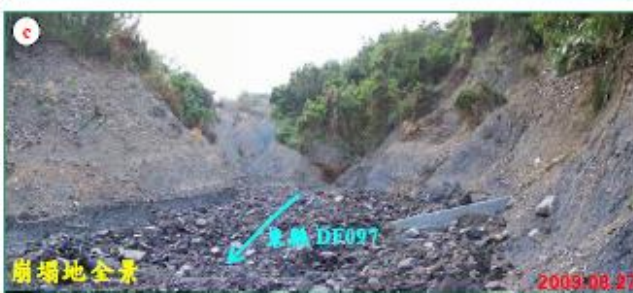
- 災害位置: 大武鄉大鳥村(台9線420.5k旁)
- 災害發生時間: 8月8日15時
- 災害類型: 土石流(東縣DF097與東縣DF098)
- 有效累積雨量: 951.0mm

- 民宅大鳥346號等8戶, 以及無門牌鐵皮屋及竈櫃遭土石掩埋。
- 大鳥村聯外道路亦遭土石掩埋。
- 本次土石災害危害範圍甚廣, 所幸村長即時進行村民之疏散避難, 因此並無人員罹難。
