The Information of Ping Ding Station

The disaster report

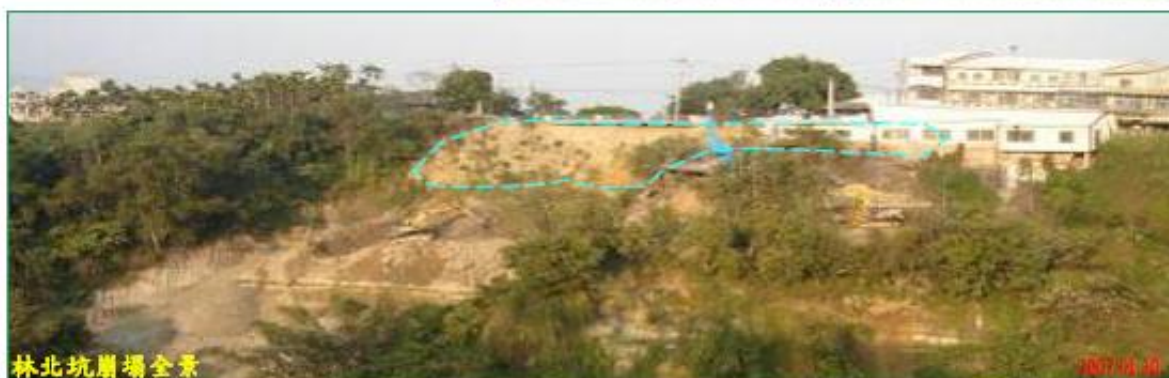
950609 豪雨-雲林林內-001

- 災害位置：林內鄉坪頂村(林北坑)
- 災害發生時間：6月9日17時
- 災害類型：崩塌災害(山崩)
- 有效累積雨量：250.7mm

- 雲61線公路之坪頂村入口路段
基邊坡土石崩塌約20公尺。
- 人命損失：0人
- 倉庫受損：2棟

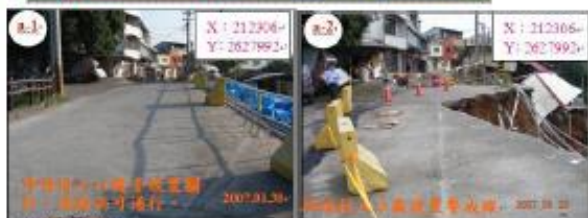
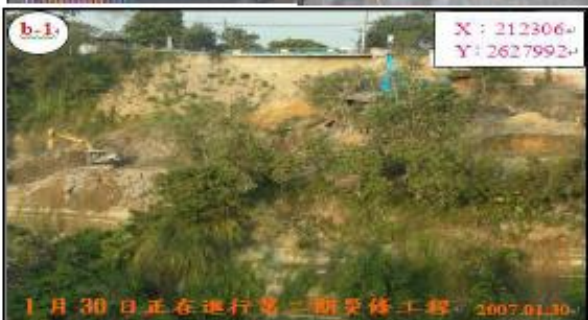
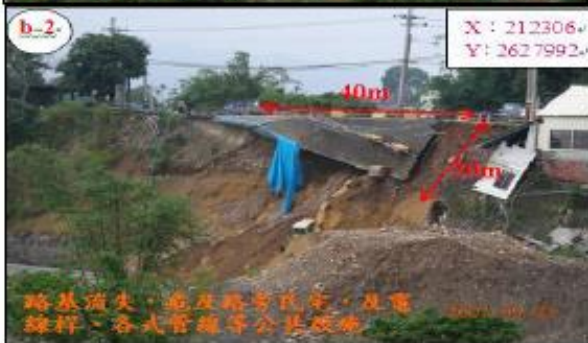
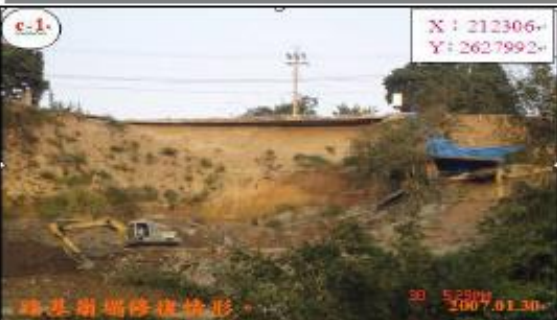
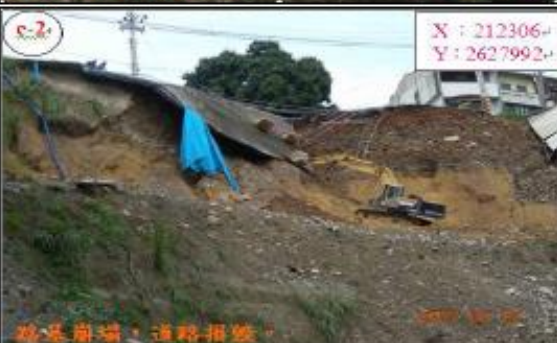
- ◆災害位置：雲林縣林內鄉坪頂村
- ◆災害發生時間：5月22日6時
- ◆災害類型：崩塌災害
- ◆有效累積雨量：66.4mm
- ◆災情描述與統計：
 - ✓ 貫 81 線公路之坪頂村入口段路基邊坡土石崩塌，路基流失約 40 公尺。
