The Information of Shang-an Station

In 1996, typhoon Herb caused more than one thousand millimeters of heavy rain a day in Shang-an area. The forests in upstream of Sanbukeng river were damaged, causing serious debris flow in midstream and upstream of Sanbukeng river, and Chenyoulan river risen suddenly. Jiji earthquake in 1999 caused collapse of 40 buildings, and the broken geological structure became more loose. Furthermore, in 2001, typhoon Toraji brought torrential rain and debris flow pour down the Sanbukeng river, causing disasters such as casualties, bridges, roads and buildings were collapsed. In order to pre-warn the occurrence of debris flow, Soil and Water Conservation Bureau completed the construction of the Shang-an station in Shang-an Village, Shuili Township, Nantou County in 2002 (The potential debris flow torrent number, Nantou County DF165).

The instrument erection of Shang-an station

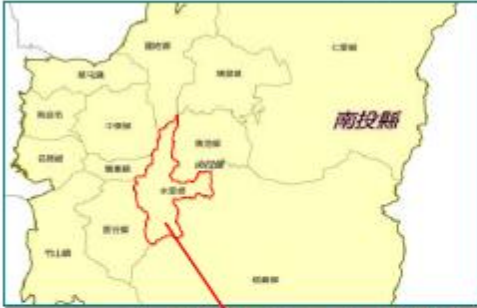
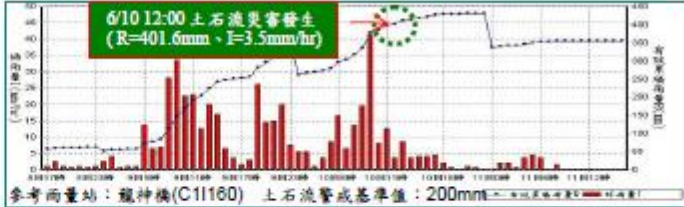
南投縣—水里鄉上安村

950609 豪雨-南投水里-001
 ◆災區位置：水里鄉上安村 (三廊坑溪)
 ◆災害發生時間：6月10日12時
 ◆災害類型：土石流災害
 ◆有效累積雨量：401.6mm

◆災情描述與統計：
 ✓安山三號橋旁道路遭淤埋 80 公尺。
 ✓右岸支流土石溢流河道，淤埋三廊巷 20 號前庭院及左側道路。
 ✓支流匯流口下游河道土石堆積堵塞。
 ✓安山三號橋孔遭土石堵塞。
 ✓人命損失：0 人 ✓房屋受損：0 棟
 ✓道路致損：約 80 公尺。
